PRIMARY RECORD

Resource Identifier: Colfax Forest Fire Station

P10. Report Citations: (Provide full citation or enter "none") A Survey and Historic Significance Evaluation of the CDF
Building Inventory, 1994 Mark V. Thornton

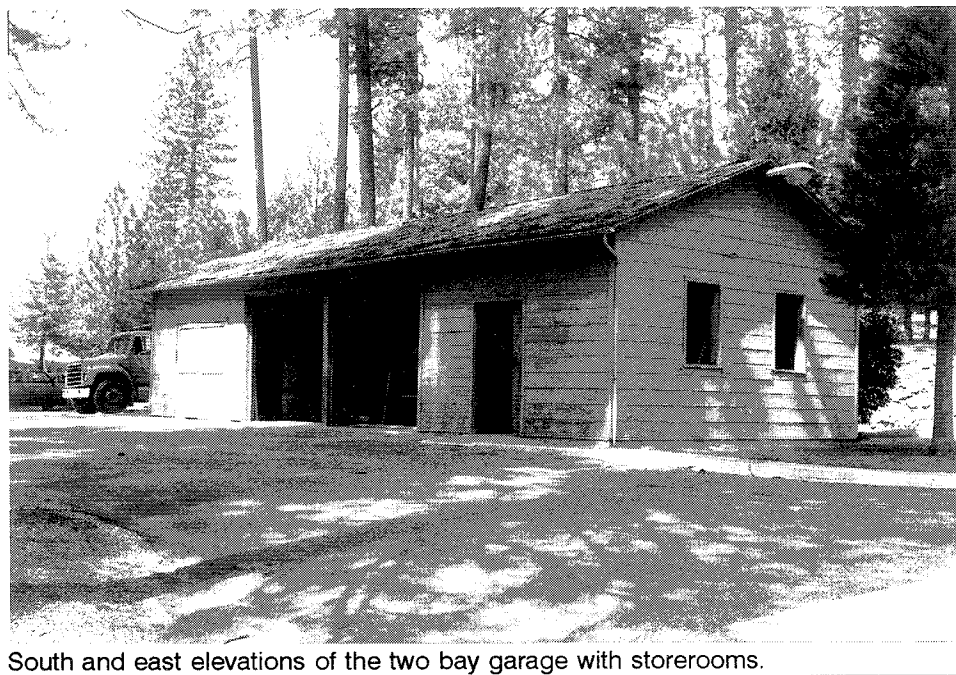
A 1936 two stall garage is located at this station. The 1,130 square foot building has a concrete slab foundation, "v" rustic siding, open eaves (rain gutter front side), and wood shingles on a gable roof. The north slope of the roof is overlaid with corrugated metal sheeting. Fenestration is basically as originally designed. The windows have been removed from the east gable end. A 1 pane/1 panel door and 6 light wood frame window are located on the west gable end. The two vehicle stalls are centered between gable end storerooms. The vehicle entries are on the south elevation and have overhead aluminum sectional doors. Centered gable side on the rear (north) elevation is an extended shed roof covered 6' x 25' bay. Three 4 light windows are centered on the north bay wall. The south elevation entries to the storerooms consist of a hinged double door on the left and an overhead track sliding door on the right. A 5.5 foot high quartz and slate stone retaining wall is behind the garage. The other buildings on the compound are a 1951 combination office and 3-bay apparatus building, a 1954 combination barracks, and a 1965 gas and oil house. The compound is covered with native pines, cedar and oak. A large lawn area and shrubbery are around the combination barracks. The station is located in a hilly, residential area.

South and east elevations of the two bay garage with storerooms.

Corrugated metal roofing added to north slope, windows removed east side, date(s) unknown. Garage doors replaced late 1960s (estimate).

The building is based on the USFS-CCC "J-13" working plan series. Only two "J-13" garages are in the CDF building collection. The Colfax garage served initially as the station's fire truck garage. After construction of the apparatus building in 1951 the building served as a warehouse and residence garage. The ranger's residence was demolished a few years ago. Although the garage is in a deteriorated state, it has not been remodeled and retains most of its historic architectural integrity.

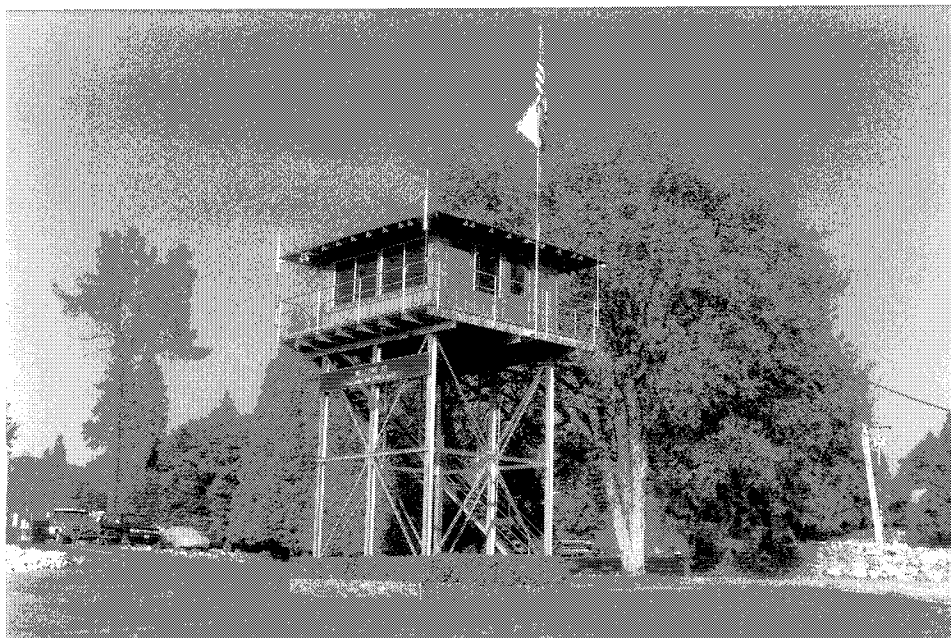
A wood frame air control office is located upon a nonbattered, steel tower. The 20 foot tall tower has a concrete pier foundation and is 14' x 14.5' with a 20' x 20' catwalk platform. The four tower legs are 6" x 6" steel I-beams. The 196 square foot cab is a square wood frame building. It has plywood panel siding, 1/1 aluminum frame sliding windows, plain fascia, and corrugated metal over a pyramidal hip roof. A small hedge with low, stone wall border is around the base of the tower. Additional landscaping around the tower includes a large lawn, pine, and oak trees. A 1960 shop building, a 1982 combination barracks, and a 1985 shower facility are also located at the base. The compound is on the northeast side of the Columbia airport runway.

West and south elevations of the control tower.

The tower was originally erected circa 1935 upon Jakeys Hill in the Eldorado National Forest. It was relocated to the airport in 1965. The original cab was replaced with existing wood frame building.

The tower is a USFS-CCC "L-4" design type. The "L-4" was used at a number of CDF and Forest Service fire lookout stations. The original cab was based on the USFS-CCC "C-3" working plan series. The replacement cab at Columbia does not conform to the original "C-3" design. There are no other "L-4" tower types in the CDF building collection that have been relocated to an air attack base. There are two "L-4" towers in the CDF fire detection system.

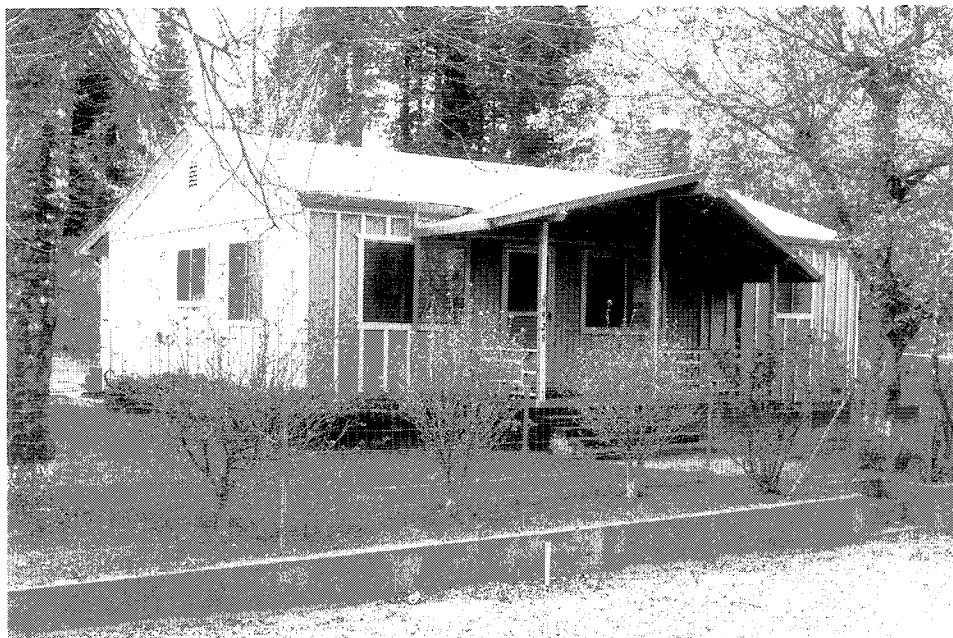
A 1935 former combination barracks, a 1937 three bay garage, and a 1938 former oil house are at this site. The combination barracks was converted to a residence in the 1960s and now serves as an office. The 1,179 square foot single story wood frame building has a "T" floor plan. It also has a concrete perimeter foundation, redwood panel and batt siding, enclosed eaves, and asphalt composition shingles over a cross-gabled roof. A 4' x 10.5' concrete porch with gable front roof is centered eave side at the top of the "T." Wall cladding immediately around the front door consists of redwood channel siding. A brick chimney is on the north slope of the principal roof. The building has an internally accessed 10' x 23.5' poured concrete basement. The 780 square foot garage has a concrete slab foundation, redwood panel and batt siding, plain fascia, and asphalt composition shingles over a gable roof. The three vehicle entries are on the northwest elevation and have overhead fiberglass sectional doors. Side doors are off-set to the north on each gable end. Behind the garage is an 84 square foot well pump house that is believed to have originally been used as a gas and oil house. The building has a concrete slab foundation, plywood and batt siding, 1/1 aluminum frame window, open eaves, and asphalt composition shingles over a simple gable roof. The batten on all three buildings have been accentuated with light colored paint. (See continuation page)

Eastern and northern elevations of the former combination barracks.

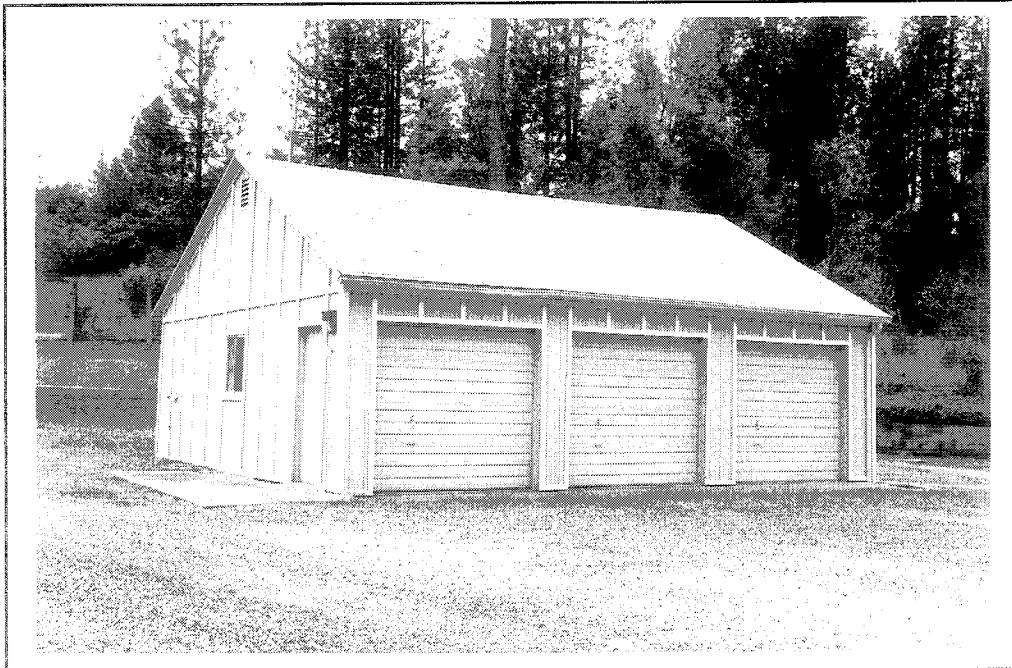
Eastern and northern elevations of three bay garage.

The building was converted from a fire truck shed to a residence garage circa 1965. It was subsequently remodeled. The vehicle stall doors were probably replaced in the 1960s.

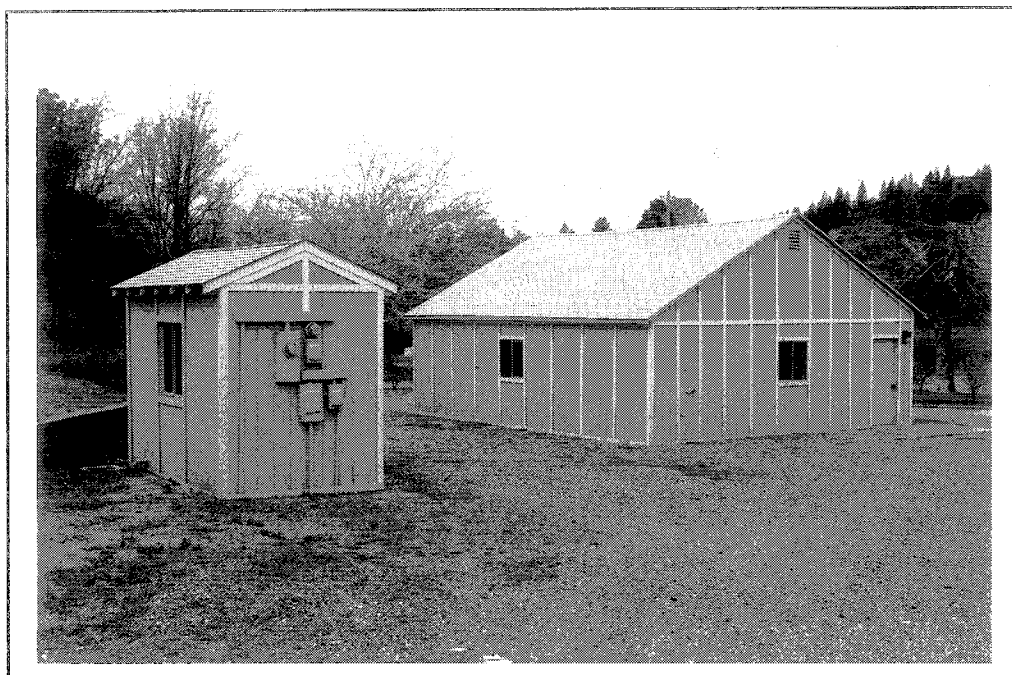
Southeastern side of well pump house with three bay garage on the right.

The original oil house is believe to have been remodeled and converted to the present well pump house circa 1958. The building was later remodeled to match thematic design of associated garage and residence. The roof was repaired in 1975 after water pressure tank explosion had damaged it.

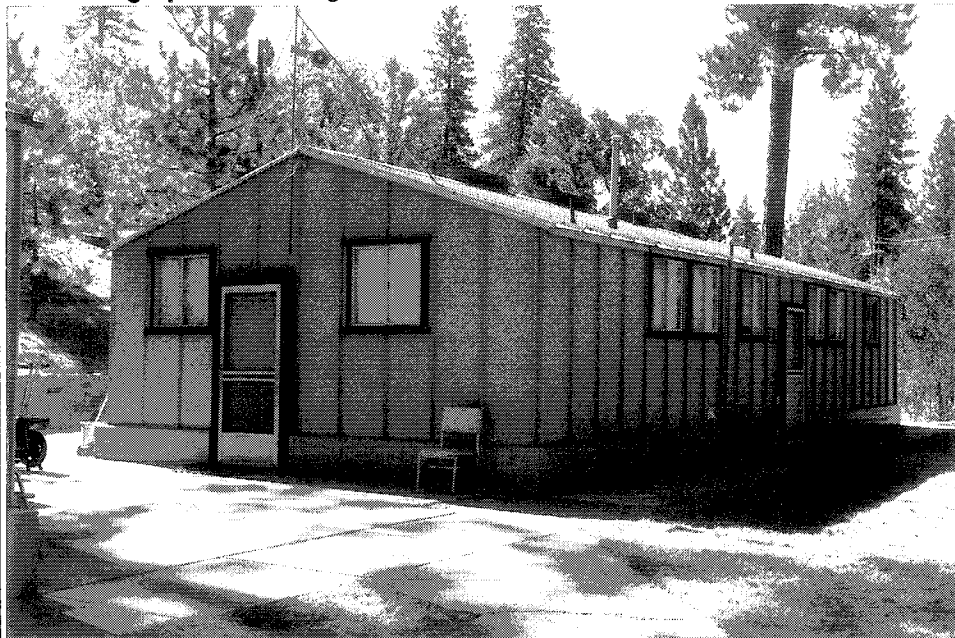
Two buildings located at this station are constructed of Army surplus material. They were erected here in 1948. The barracks and the combination kitchen-messhall buildings both have concrete slab foundations, ribbed metal siding, 1/1 aluminum frame sliding windows, and ribbed metal roofing over simple gable roofs. Entries are centered on each gable end with another door located gable side on the west elevations. Each building has a gross measurement of 960 square feet. The barracks and kitchen-messhall share a common building pad that has been cut into a west aspect slope. A rock and cement retaining wall runs behind the buildings. There are lawns around both of them. A short distance downhill to the northwest is a 1952 combination office and two bay truck garage. A one-pump gas and oil house is also located on this lower level. Two circa 1967 water system outbuildings are also on the compound. A small stand of regrowth pine covers the slope between the upper and lower building pads. The surrounding area is covered with a mixture of pine and oak with understory brush and grasses.

North and west elevations of the barracks.

Windows, doors replaced 1970s (estimate).

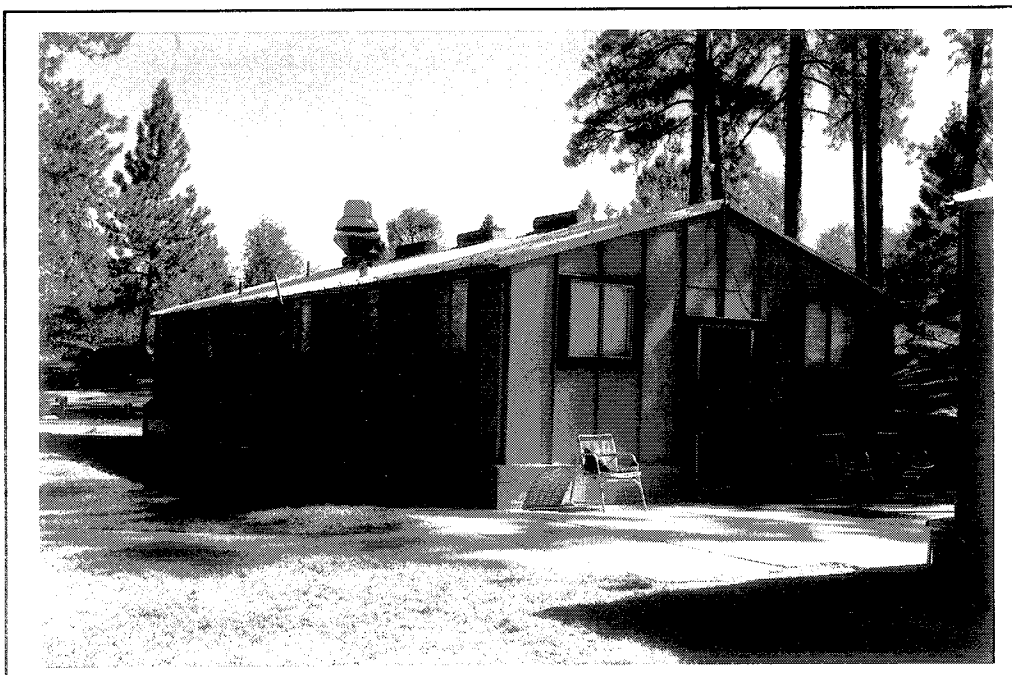
West and south elevations of the combination kitchen and mess hall.

Windows, doors replaced 1970s (estimate).

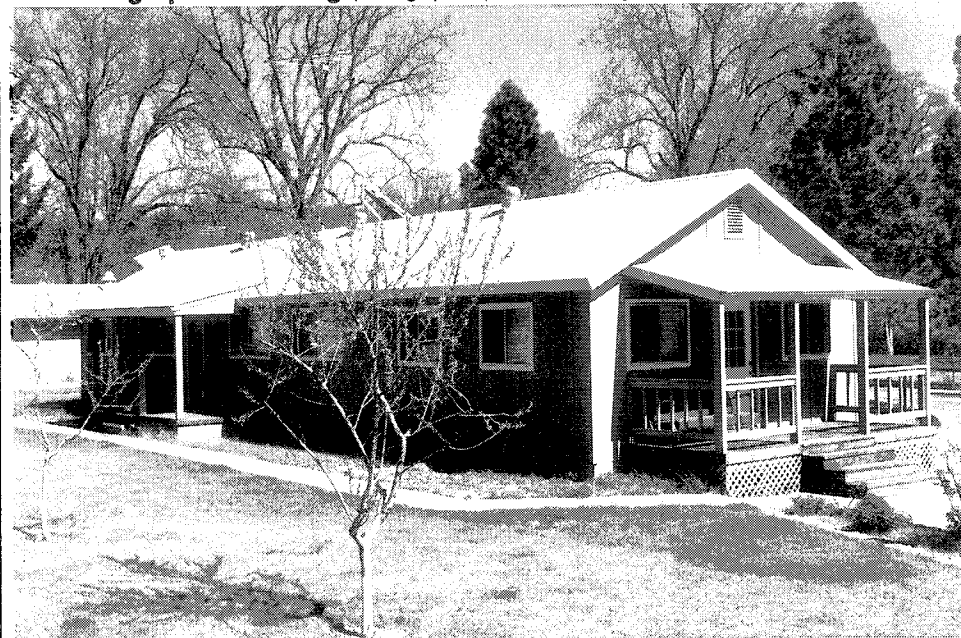
The original portion of the barracks at this site was constructed in 1936. The rectangular building had a gable wing bathroom addition added circa 1958. The southwest end of the building was lengthened circa 1990. The barracks now has a gross measurement of 1,524 square feet. It also has a concrete perimeter foundation, plywood and batt siding, 1/1 aluminum frame windows, enclosed eaves, and asphalt composition shingles over a tri-gabled roof. The front entry for the barracks is located eave side on the northwest elevation. An extended shed roof shades this entry. Another entry is located on the southwest gable end. The 6' x 16' redwood deck porch at this end has a shed roof covering. The wood roof supports have wood rails with pickets between them. A gable roof covered utility closet is located on the northeast gable end of the barracks. A rear entry with a 4' x 8' concrete deck is on the gable end of the bathroom addition. On the southwest side of this wing is an extended shed roof covered utility closet. The closet is in-set in the southeast corner of the barracks-bathroom wall junction. The compound also includes a 1952 combination office and two bay truck garage, a 1966 combination kitchen and messhall, and a small storage shed. The station is located upon level ground. Landscaping, including lawn and trees, is around the office-barracks and kitchen-messhall.

Southwest side of the barracks.

The combination barracks was remodeled circa 1958 with bathroom wing added. A separate kitchen-messhall was constructed in 1966. The subject building was remodeled into a 10-man barracks in 1967 (windows replaced, etc). Asphalt composition shingles added circa 1973, new siding circa 1978, and a west addition circa 1990.

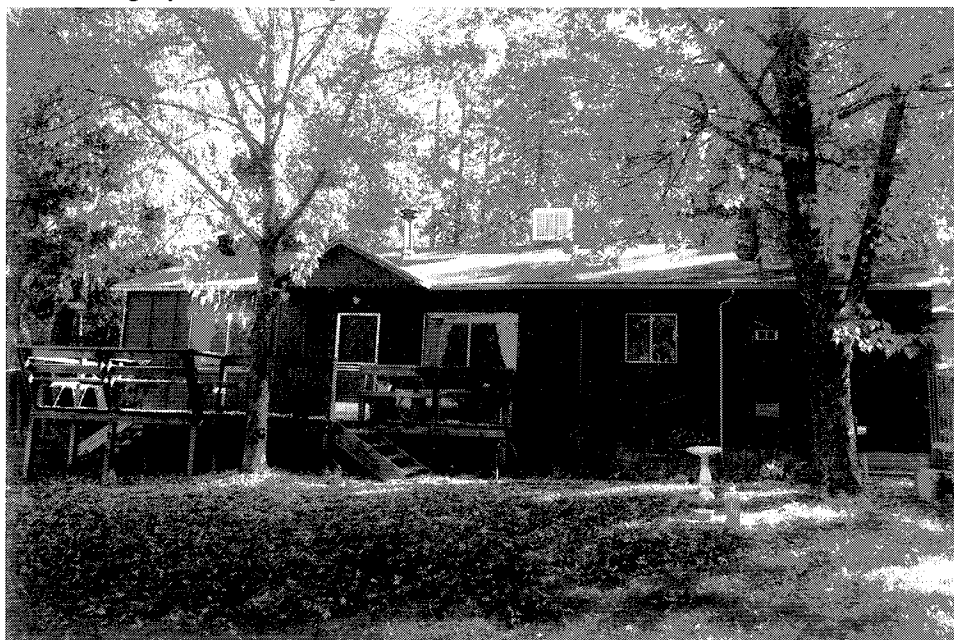
The original fire station facilities are located down slope to the north of the current fire station. The old compound consists of a 1938 combination barracks and a 1938 two stall truck garage. The barracks was converted to a ranger's residence circa 1965. The 1,181 square foot building has a concrete perimeter foundation, plywood panel and batten siding, plain fascia (boxed eave on the front elevation), and asphalt composition roofing over a simple gable roof. Louvered attic vents and beveled siding are in the gables. The gable side front entry is on the west elevation. A diminutive gable front roof is cantilevered over this entry. An approximately 17' x 10' redwood deck extends across part of the front elevation. A gable roof service porch is on the south gable end of the building. A cantilevered shed roof with knee bracing shades the gable end door on this small addition. A rock and cement retaining wall runs behind the building. The front yard has been fenced to buffer the noise from State Highway 120. The 832 square foot garage is a rectangular wood frame building with concrete slab foundation, "v" rustic siding, plain fascia, and corrugated metal panels over a gable roof. The floor plan consists of two vehicle stalls and one storeroom. The vehicle entries have hinged double doors. A dropped shed roof with log post supports covers the storeroom entry. Divided light wood frame windows are on three elevations. (See continuation page)

West elevation of the former combination barracks (ranger's residence).

The original building was remodeled and converted to a residence in 1965-66, small addition constructed, siding, windows, doors and roofing replaced.

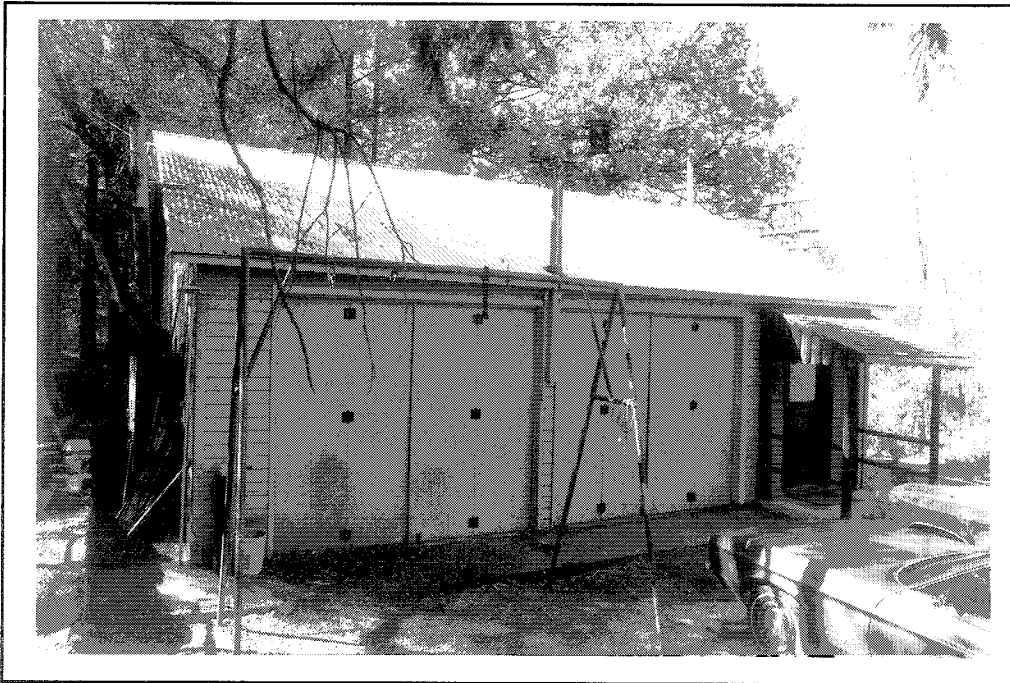
Eastern elevation of the two bay residence garage.

Doors replaced, shed roof over entry added date(s) unknown.

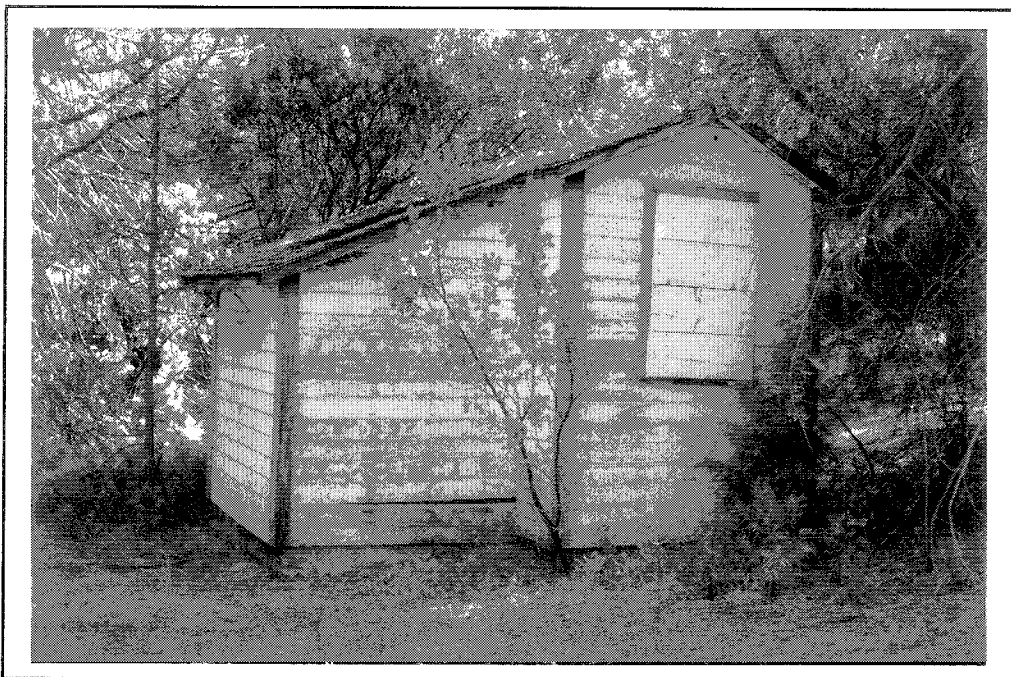
Off-site is a 101 square foot well pump house. It has a concrete slab foundation, "v" rustic siding, open eaves, and wood shingles on a "saltbox" gable roof. The pump house is not used by the station, and is upon private land.

West side of the off-site well pump house.

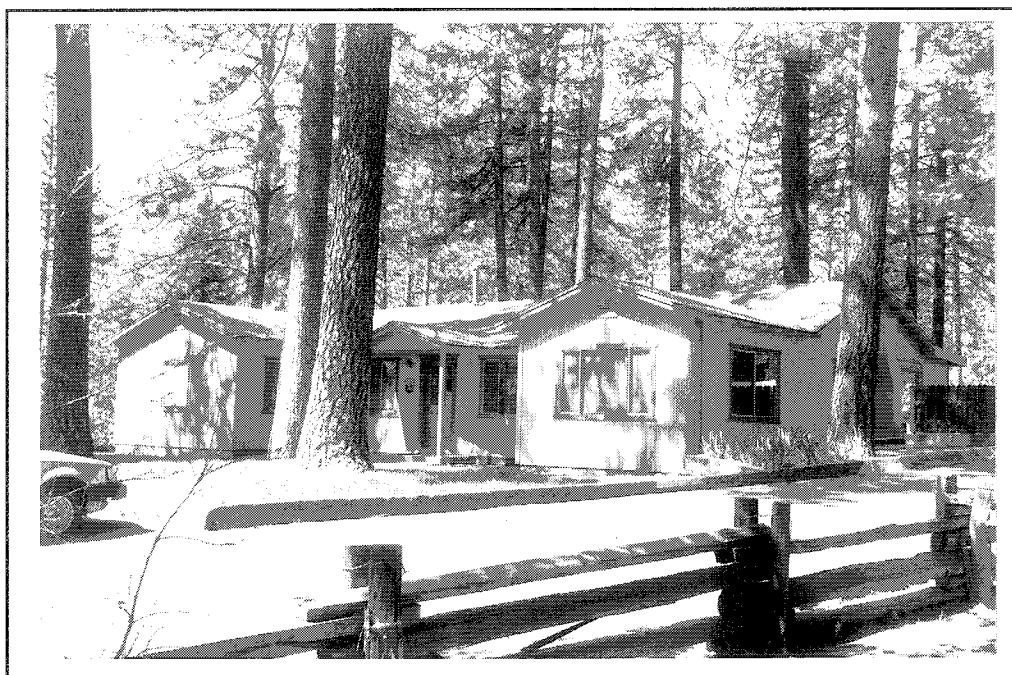
The foundation under the central (older) section of the office is concrete perimeter while concrete slab is under the front wings and other added sections. The front entry is centered between the front facing gable wings. A gable front porch roof supported by two wood posts shades the front door. Windows across this southeast elevation are 1/1/1 aluminum frame sliders (center pane is fixed). Aluminum frame 1/1 sliding windows predominate on the rest of the elevations. A small, full width addition on the northwest elevation is covered with a nearly flat extended shed roof. An extended shed roof on this addition covers a rear entry. The office also has a small poured concrete basement which is accessed from an external trap door on the southwest side.

Southern elevation of the administration office.

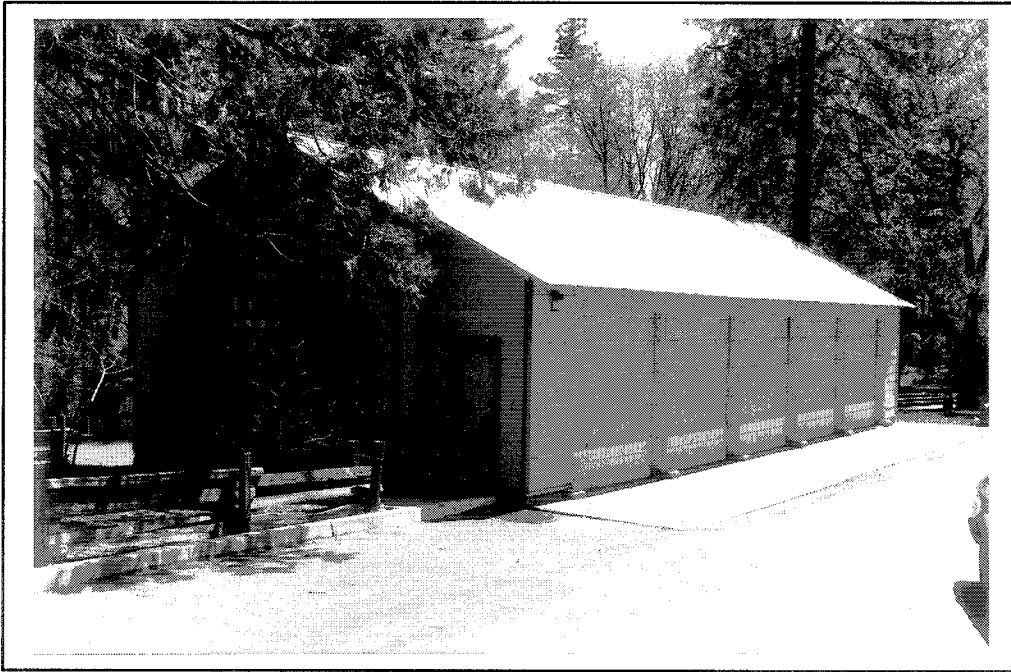
The 1,560 square foot five bay equipment garage has a concrete slab foundation, 10" "v" rustic siding, diminutive fascia, and corrugated metal sheeting over a gable roof. The five vehicle stalls have fiberglass sectional overhead doors. A 2' x 15.5' bay is centered on each gable end. The gable end of these bays is covered with channel tongue and groove siding. Centered on the gable ends of the bay walls are four large 12 light wood frame windows. Roofing beams extend into each gable. A row of five 6/6 wood frame windows is on the north (rear) elevation of the garage.

Northern and western elevations of the five bay truck garage.

Garage doors replaced late 1960s (estimate).

This is a classic example of a USFS-CCC "L" type garage. There are only three of these 27' x 60' five bay garages in the CDF building collection. This one has the highest historic architectural integrity. The only significant Blanchard and Maher detail missing here, is their trademark three panel "chevron" louvered attic vents.

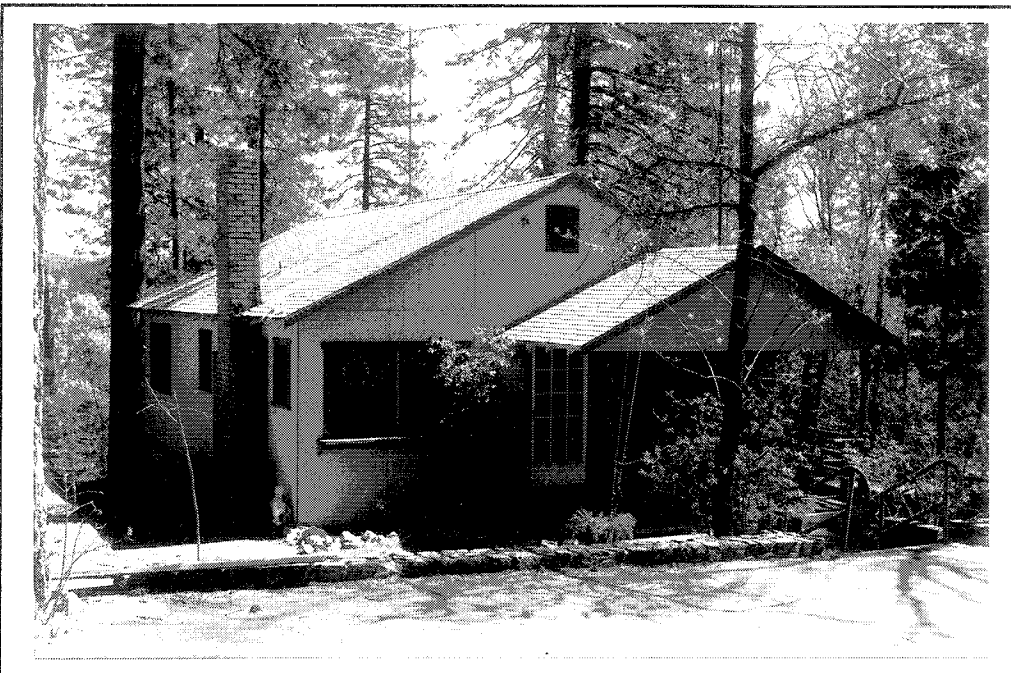
The residence is located on a northeast facing slope. It is a split level building with lower basement (walls exposed on the north, east, and south sides). The 1,021 square foot building (not including the basement) has a concrete perimeter foundation (slab floor for the basement) pressed hardboard siding, 1/1 aluminum frame single hung windows, open eaves and a gable roof. Paired 1/1 windows flank a centered front door on the west gable end. A gable front porch roof is off-set to the right on this elevation. A small walk extends across the front of the house and wraps around the right corner to continue along part of the south elevation. It leads to a side porch and south gable wing addition. The 8' x 12' addition extends beyond the side porch's roof creating a gable-on-gable design. A brick chimney is located eave side on the north elevation.

Northern and western elevations of the residence.

Windows, siding replaced late 1980s (estimate), date of south addition is unknown.

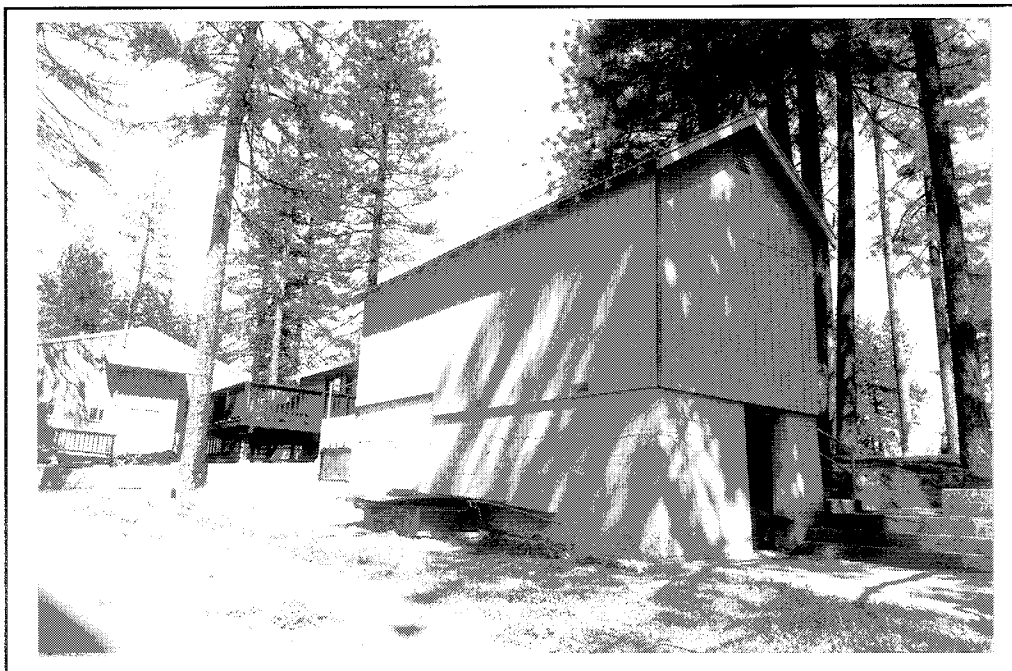
The 324 square foot walk-in cooler is a rectangular wood frame building with pressed hardboard siding, open eaves, and asphalt composition shingles over a gable roof. The foundation is a concrete basement with exposed southern and western elevations. A door on the southwest elevation provides access to the basement. A door on the northeast elevation of the upper floor provides access to the refrigeration room. A breezeway runs between the walk-in cooler and the kitchen-messhall-office building.

Western and southern elevations of the walk-in cooler.

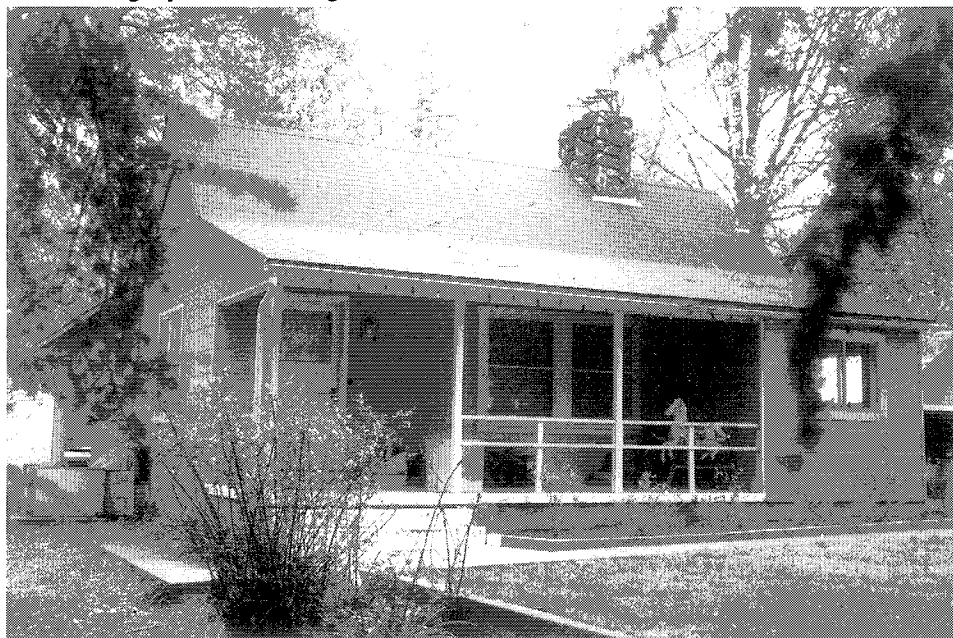
The Mount Zion State Forest residence site has a 1934 ranger's residence, office, and residence garage. The 1,281 square foot residence is a rectangular single story wood frame building. It has a concrete perimeter foundation, "V" rustic siding (12" on two sides, 8" on the other sides), and asphalt composition shingles over a tri-gabled roof ("T" pattern). The front entry is at the top of the "T" being recessed under the northwest corner of the roof. The west slope of the front gable (top of the "T") has a two pitch design. A stone chimney is on the west slope near the ridge. The 20' x 7' entry porch has a concrete floor. The roof overhang covering the porch is supported by three 4" x 4" chamfered posts. The front door has a 1 pane/3panel design. To the right of the door are two 8/1 wood frame double hung windows. A single 1/1 aluminum frame sliding window is located to the right of the porch area, on the west elevation. Fenestration appears to be original for this house but 1/1 aluminum frame sliding windows are on the south and east walls. The north elevation has a combination of 2/4 and 4/4 double hung wood frame windows. The front elevation eave is enclosed, the other eaves have only a fascia. The house also features a 20' x 25' internally accessed concrete basement. The 300 square foot office now serves as a guest cabin. The rectangular wood frame building has a concrete perimeter foundation, "V" rustic siding (12" on two sides, 8" on the other sides), 4/4 double hung wood frame windows, fascia, and wood shingles on a gable roof. (See continuation page)

North and west elevations of the ranger's residence.

Siding replaced south and east elevations. Newer roofing 1960s (estimate), replacement windows 1980s (estimate).

C. Raymond Clar's, *California Government and Forestry - II: during the Young and Rolph administrations*, reports that the State surveyed Mount Zion in 1926 for a lookout site. The State owned land was transferred from the school land category to the CDF in 1932. In the winter of 1931-32 one of the State's first unemployment labor camps was established here. In 1933, a CCC camp replaced the State camp. Clar also reported that in 1932 a "group of civic minded women of Amador County had organized a Mt. Zion Improvement Club... for the purpose of improving the public recreation facilities at the site." Monies were raised for additional land acquisition. The site was designated the Mount Zion State Forest in July of 1932. The house was constructed by the CCCs. A photograph in Clar's book (page 270) of the Mt. Danaher ranger's residence is captioned "Plan was standard design by qualified architects." The Mount Zion and Mount Danaher houses appear to be identical. They're probably based on a variation of one of the USFS-CCC "A" plans. The house still retains a high degree of historic architectural integrity.

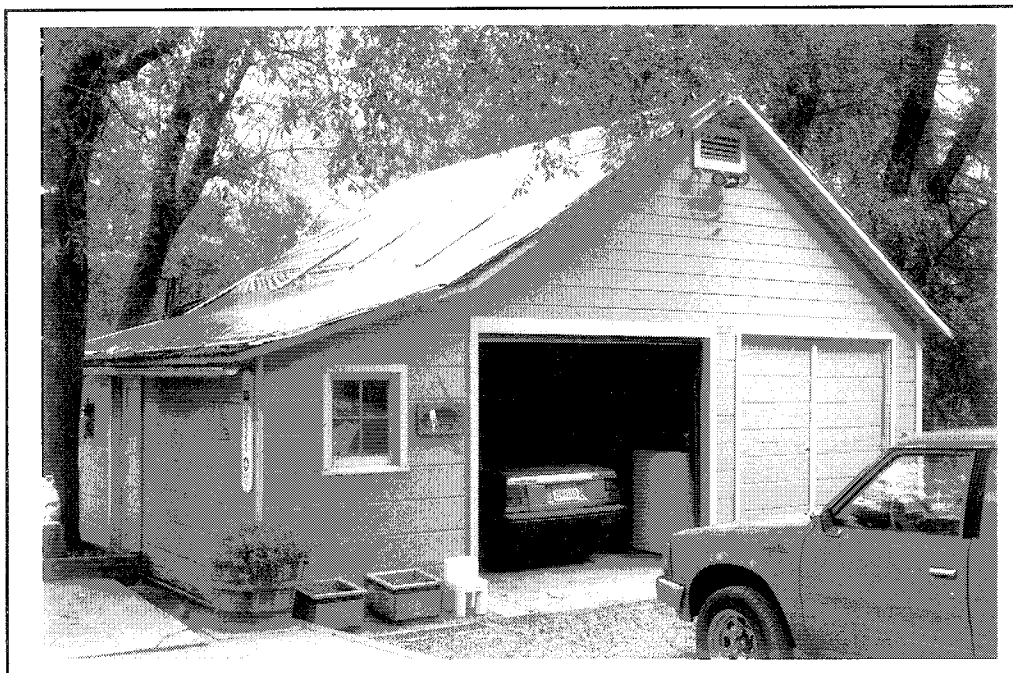
North and west elevations of the residence garage.

Siding replaced south and east elevations, date unknown.

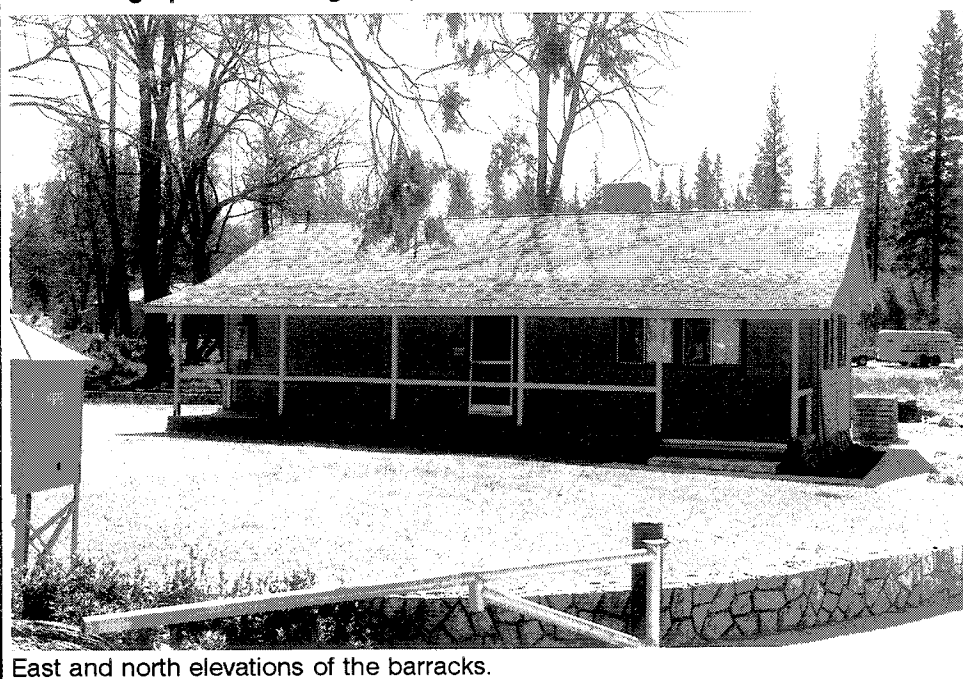
This fire station includes a 1943 barracks, a 1943 combination kitchen and messhall, and a 1949 combination office and truck garage. The 800 square foot barracks is a rectangular single story wood frame building. It has a concrete pier and wood post foundation, "v" rustic siding, 1/1 aluminum frame sliding windows, plain fascia, and wood shingles over a gable roof. The east slope of the roof is dual-pitched. The roof extends over a gable side concrete porch. The roof overhang is supported by six wood posts. The front door is centered on this side. The concrete slab porch floor rests upon a stone and mortar foundation. A rear entry is located gable side on the west elevation. Rock walls have been installed between some of the perimeter foundation piers. The 516 square foot kitchen-messhall is a single story rectangular wood frame building with small addition. The shed roof covered addition is at the west end of the north elevation. The building has a concrete pier and wood post foundation, 1/1 aluminum frame sliding windows, plywood panel siding, plain fascia, and wood shingles over a gable roof. Cinder block walls have been installed between some of the perimeter foundation piers. The building has a gable front entry. Across the front elevation is a full width porch. The porch's shed roof is supported by four chamfered wood posts. The porch floor is a concrete slab on top of a stone and mortar foundation. (See continuation page)

East and north elevations of the barracks.

Windows replaced, 1980s (estimate), newer wood shingles, date unknown. Bathroom remodeling, 1985.

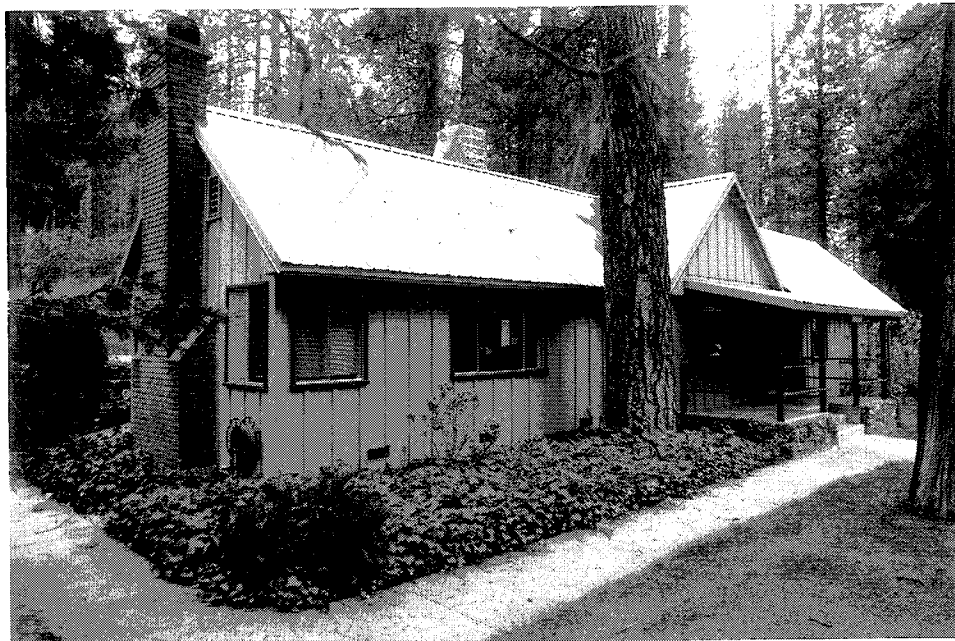
A 1936 office (converted to residence circa 1948 and then to a kitchen-messhall circa 1975) and a 1936 combination warehouse and equipment shed are located at this site. The 1,396 square foot kitchen-messhall is a single story wood frame building. It has a concrete perimeter foundation, pressed hardboard and batten siding, aluminum frame sliding windows (both 1/1 and 1/1/1), boxed eaves, and ribbed aluminum sheeting over a cross-gabled roof. The building has an asymmetrical rear facing "T" floor plan (the right wing is larger than the left wing). The left (southeast) wing constitutes the original office. The right and rear wings were added in 1948. The rear wing's roof extends northeast through the cross gable's front slope (top of the "T") ending with a gable over the front entry. A shed roof covering the front porch extends across this gable end. The porch roof is supported by four wood posts. The 20' x 6.5' concrete porch floor is about 10" above grade and is faced on three sides with natural stone. A brick chimney is located on the gable end of the left wing. A "saltbox" gable roof addition is on the southwest gable end (bottom of the "T") of the rear wing. This small addition is off-set to the right side of the rear wall. A rear entrance is located on the addition. The building pad has been cut into a northeast aspect slope. Stone retaining walls run behind and in front of the building. (See continuation page)

Northeast side of the former office-residence (combination kitchen and messhall).

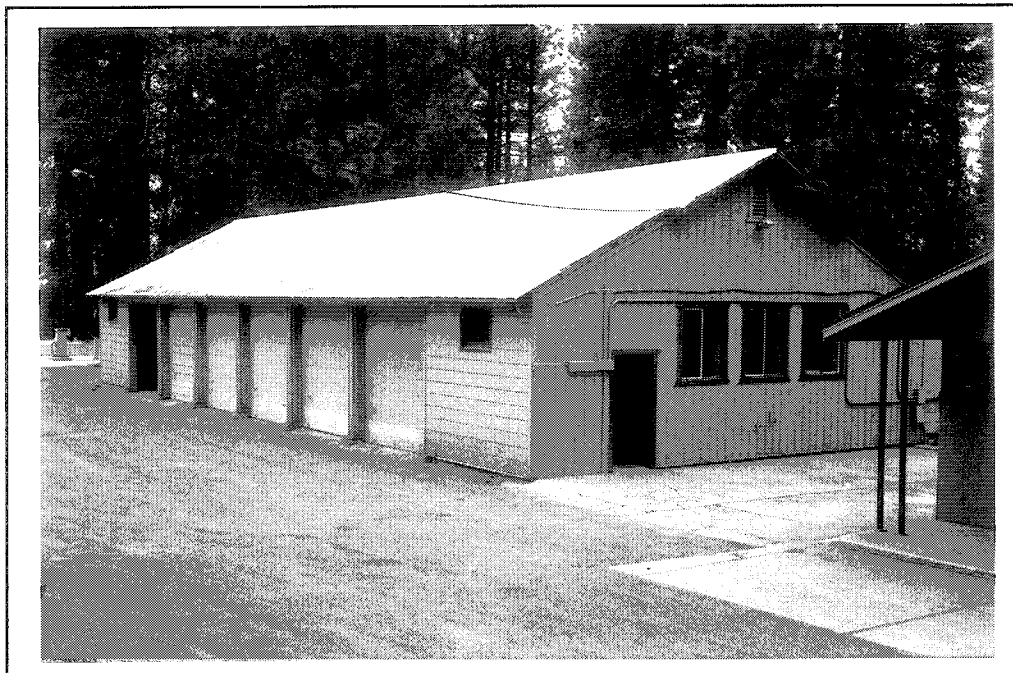
Southwest and southeast elevations of combination warehouse and equipment shed.

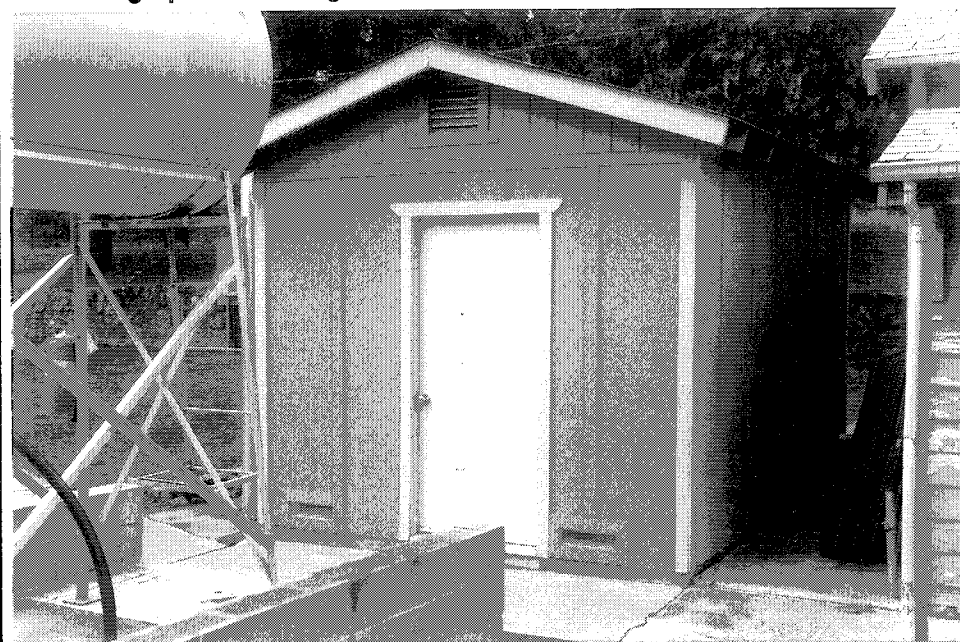
North side of the gas and oil house.

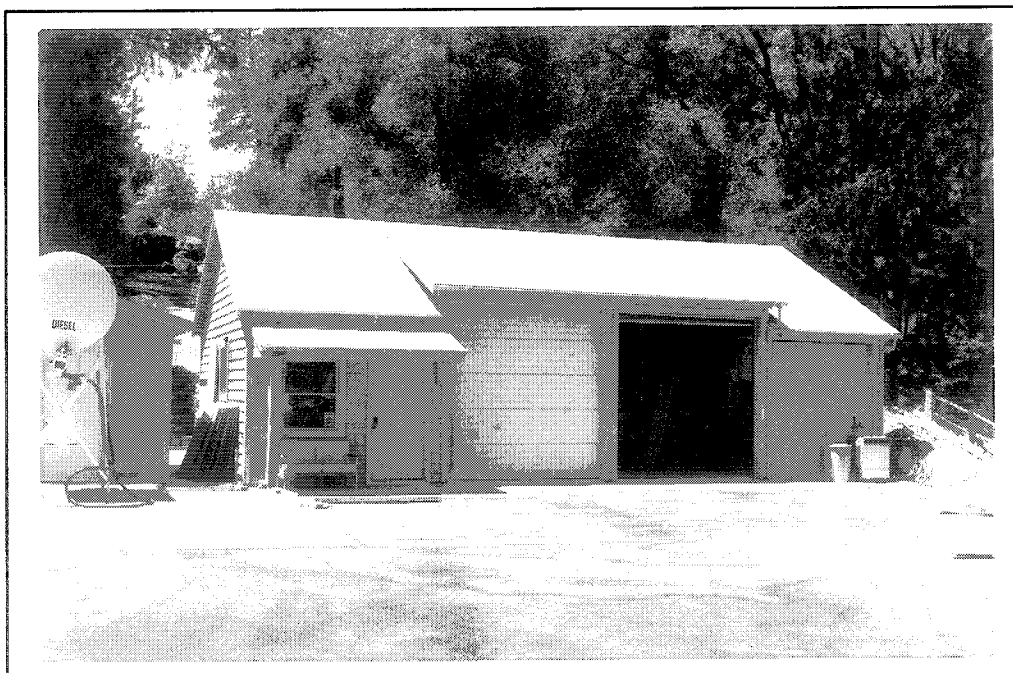
East and north elevations of the truck garage.

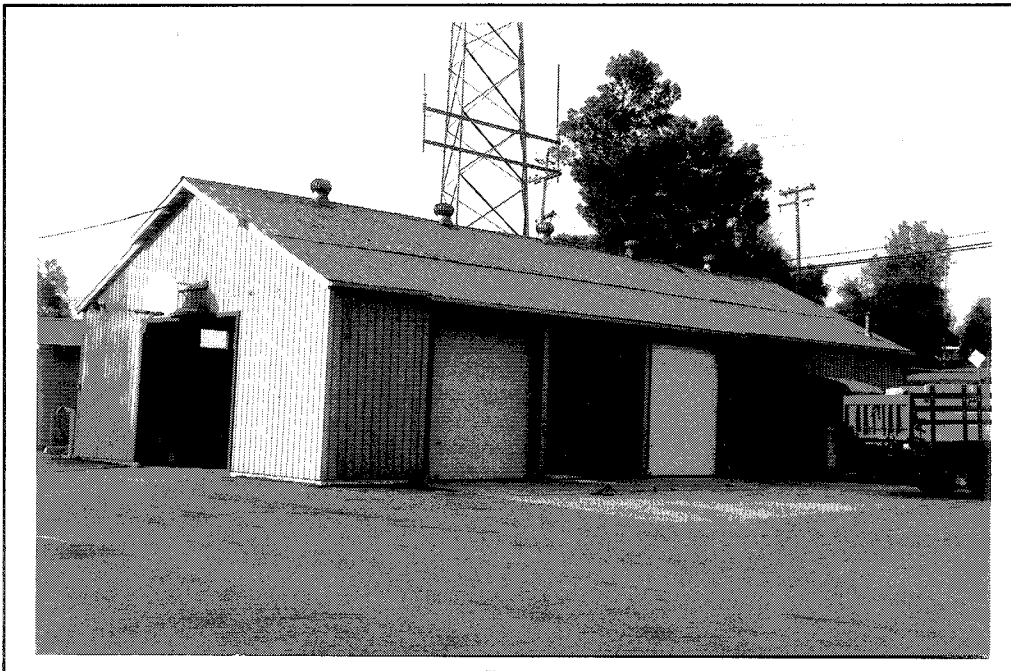
West and south elevations of the five bay equipment garage.

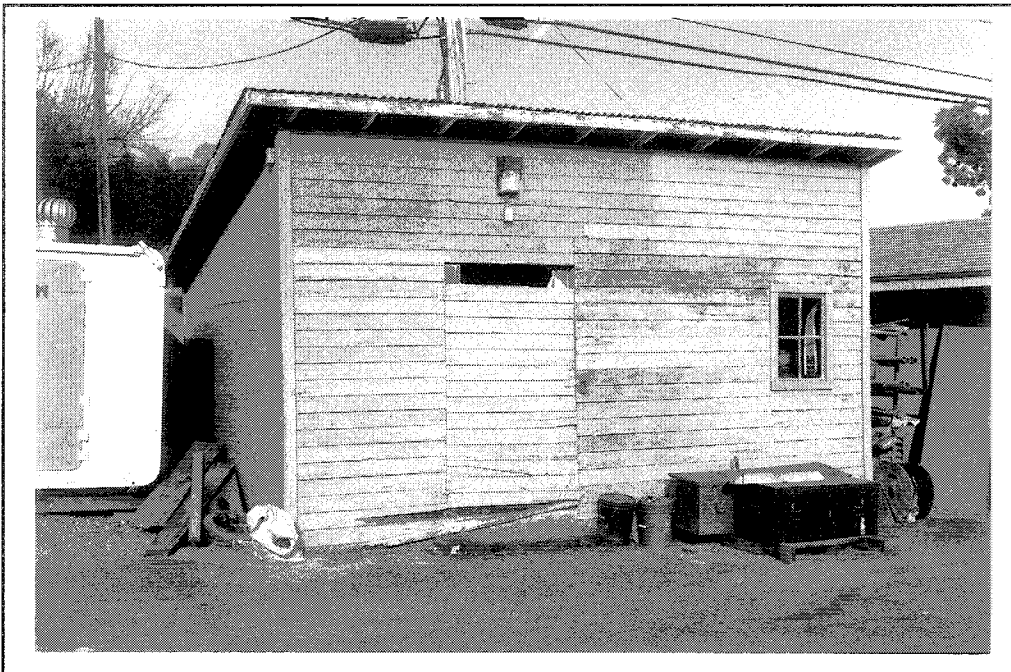
North and west elevations of the former oil house.

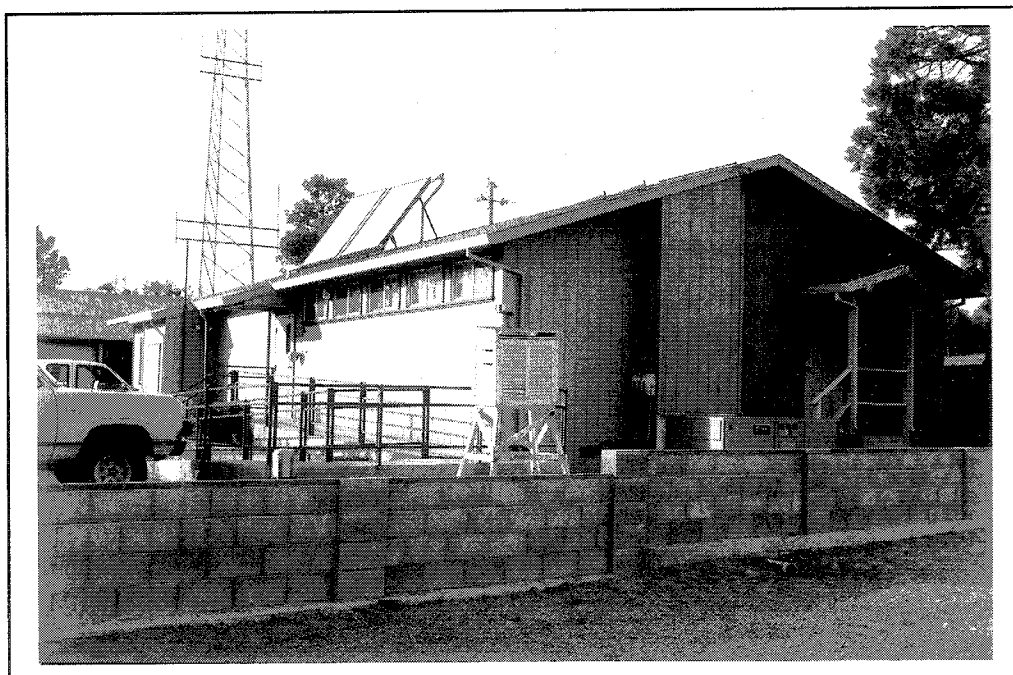
West and south elevations of the former warehouse (emergency command center).
